Smoke and Dye Testing Summary

High Level Sewershed

Test ID	Test Type	Date Inspected	Company / Super.	Blower MH	Ground Condition	Notification Made?	Total Length
S1028-060	Smoke	9/8/2008	ADS/TM	S11AA1019MH	Dry	Yes	558.28

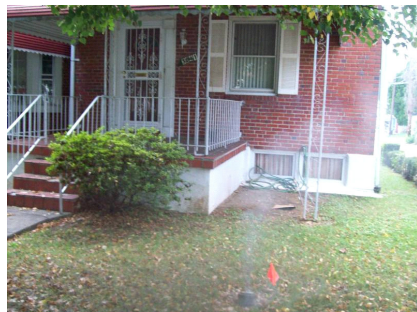
Picture \S1028-060-OB01-P01.jpg

Comments Smoke from cleanout in front yard. 3241 Dorithan Rd

Comments Front of house, 3241 Dorithan Rd

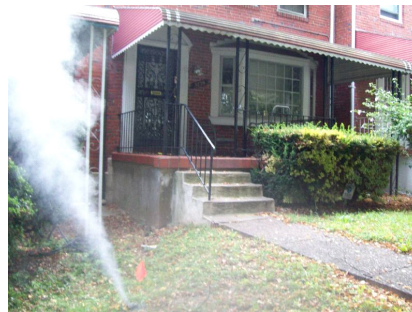
Picture \S1028-060-OB02-P01.jpg

Comments Smoke from cleanout in front yard. 3239 Dorithan Rd

Comments Front of house, 3239 Dorithan Rd

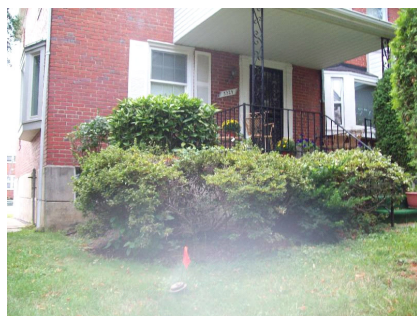
Picture \S1028-060-OB03-P01.jpg

Comments Smoke from clenaout in front yard. 3229 Dorithan Rd

Comments Front of house, 3229 Dorithan Rd

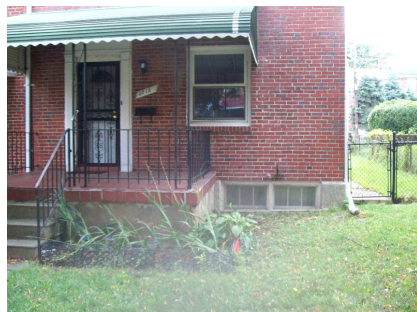
Picture \S1028-060-OB05-P01.jpg

Comments Smoke from cleanout in front yard. 3213 Dorithan Rd

Comments Front of house, 3213 Dorithan Rd

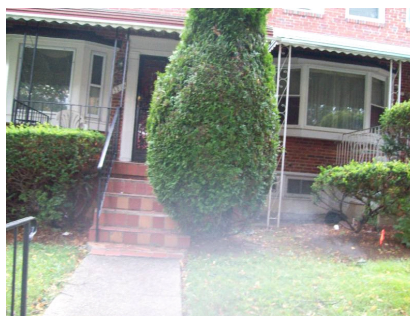
Picture \S1028-060-OB04-P01.jpg

Comments Smoke from cleanout in front yard. 3215 Dorithan Rd

Comments Front of house, 3215 Dorithan Rd

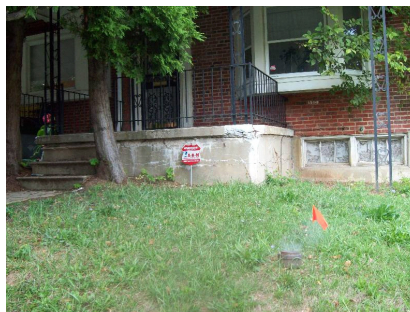
Picture \S1028-060-OB06-P01.jpg

Comments Smoke from cleanout in front yard. 3200 Dorithan Rd

Comments Front of house, 3200 Dorithan Rd

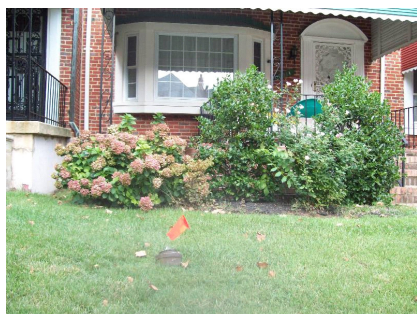
Picture \S1028-060-OB07-P01.jpg

Comments Smoke from cleanout in front yard. 3214 Dorithan Rd

Comments Front of house, 3214 Dorithan Rd

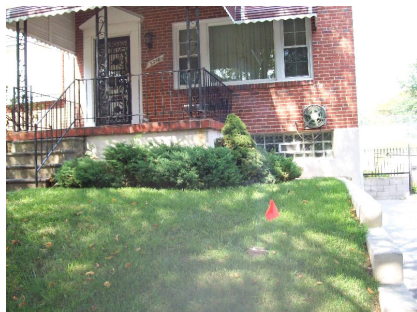
Picture \S1028-060-OB09-P01.jpg

Comments Smoke from cleanout in front yard. 3218 Dorithan Rd

Comments Front of house, 3218 Dorithan Rd

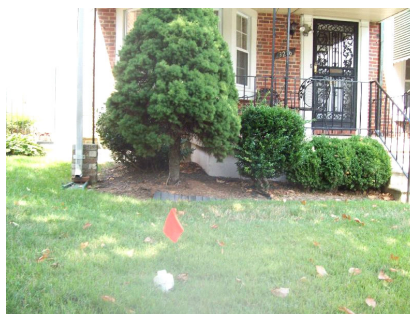
Picture \S1028-060-OB08-P01.jpg

Comments Smoke from cleanout in front yard. 3216 Dorithan Rd

Comments Front of house, 3216 Dorithan Rd

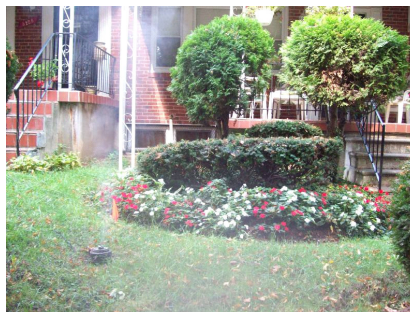
Picture \S1028-060-OB10-P01.jpg

Comments Smoke from cleanout in front yard. 3226 Dorithan Rd

Comments Front of house, 3226 Dorithan Rd

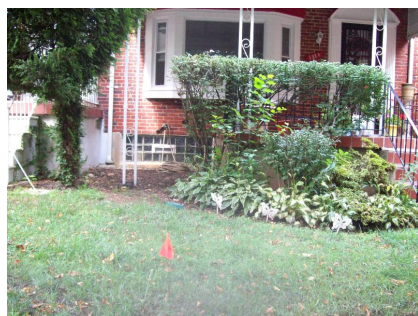
Picture \S1028-060-OB11-P01.jpg

Comments Smoke form cleanout in front yard. 3228 Dorithan Rd

Comments Front of house, 3228 Dorithan Rd

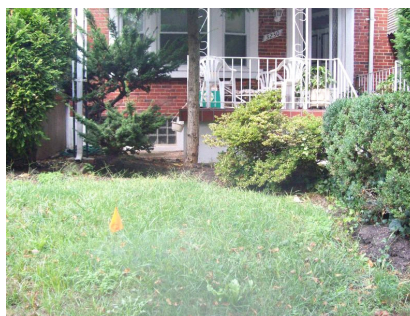
Picture \S1028-060-OB12-P01.jpg

Comments Smoke from cleanout in front yard. 3230 Dorithan Rd

Comments Front of house, 3230 Dorithan Rd

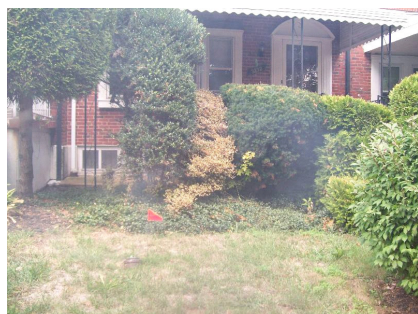
Picture \S1028-060-OB13-P01.jpg

Comments Smoke from cleanout in front yard. 3232 Dorithan Rd

Comments Front of house, 3232 Dorithan Rd

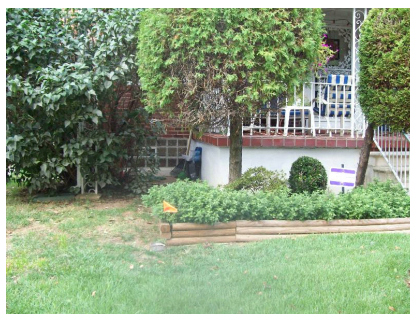
Picture \S1028-060-OB14-P01.jpg

Comments Smoke from cleanout in front yard. 3234 Dorithan Rd

Comments Front of house, 3234 Dorithan Rd
